PHASE I ENVIRONMENTAL SITE ASSESSMENT

**PROSSER LIBRARY
1 TUNXIS AVENUE
BLOOMFIELD, CONNECTICUT**

**Prepared for:
Town of Bloomfield**

SLR Proj. No.: 144.12571.00015

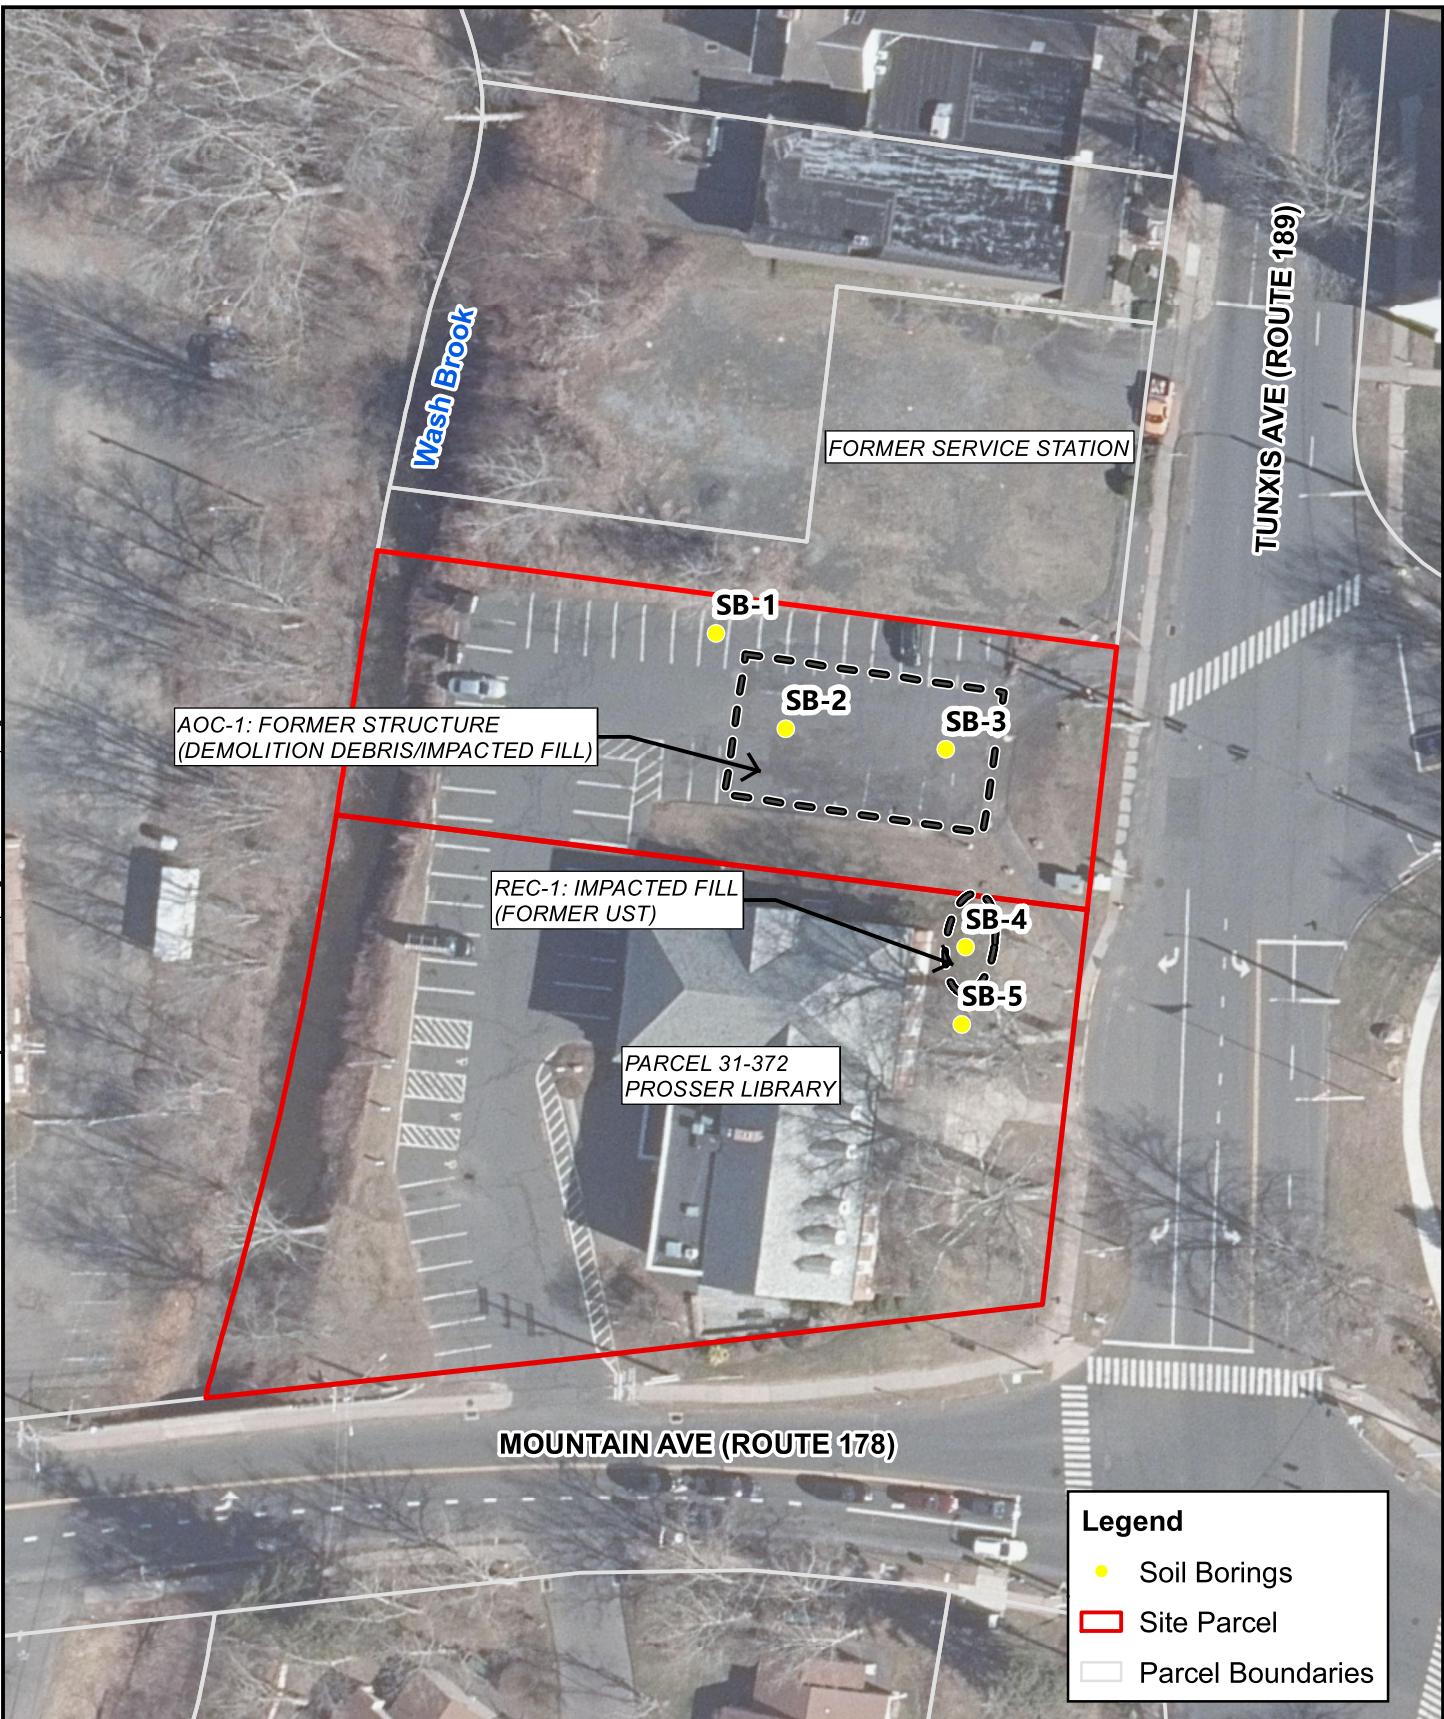
- Assess environmental media to establish the presence or absence of a release of hazardous materials or petroleum products in the RECs or AOCs identified at the Site. Figure 2 shows each of the Site AOCs addressed in this report. In this instance, the Phase II Investigation work focused on the characterization of the urban fill documented at REC-1 and potential impacts from demolition debris in AOC-1.

SLR oversaw the installation of five total soil borings, SB-1 through SB-5, by the subcontracted driller, Soil Testing, LLC on May 12, 2022. The soil borings were logged by SLR field personnel, and the soil was screened for visual staining, odors, or other evidence of impact. In addition, the presence of VOCs was evaluated using a calibrated PID. Attached Figure 2 shows the site boring locations, and a copy of the soil boring logs is included as Appendix A.

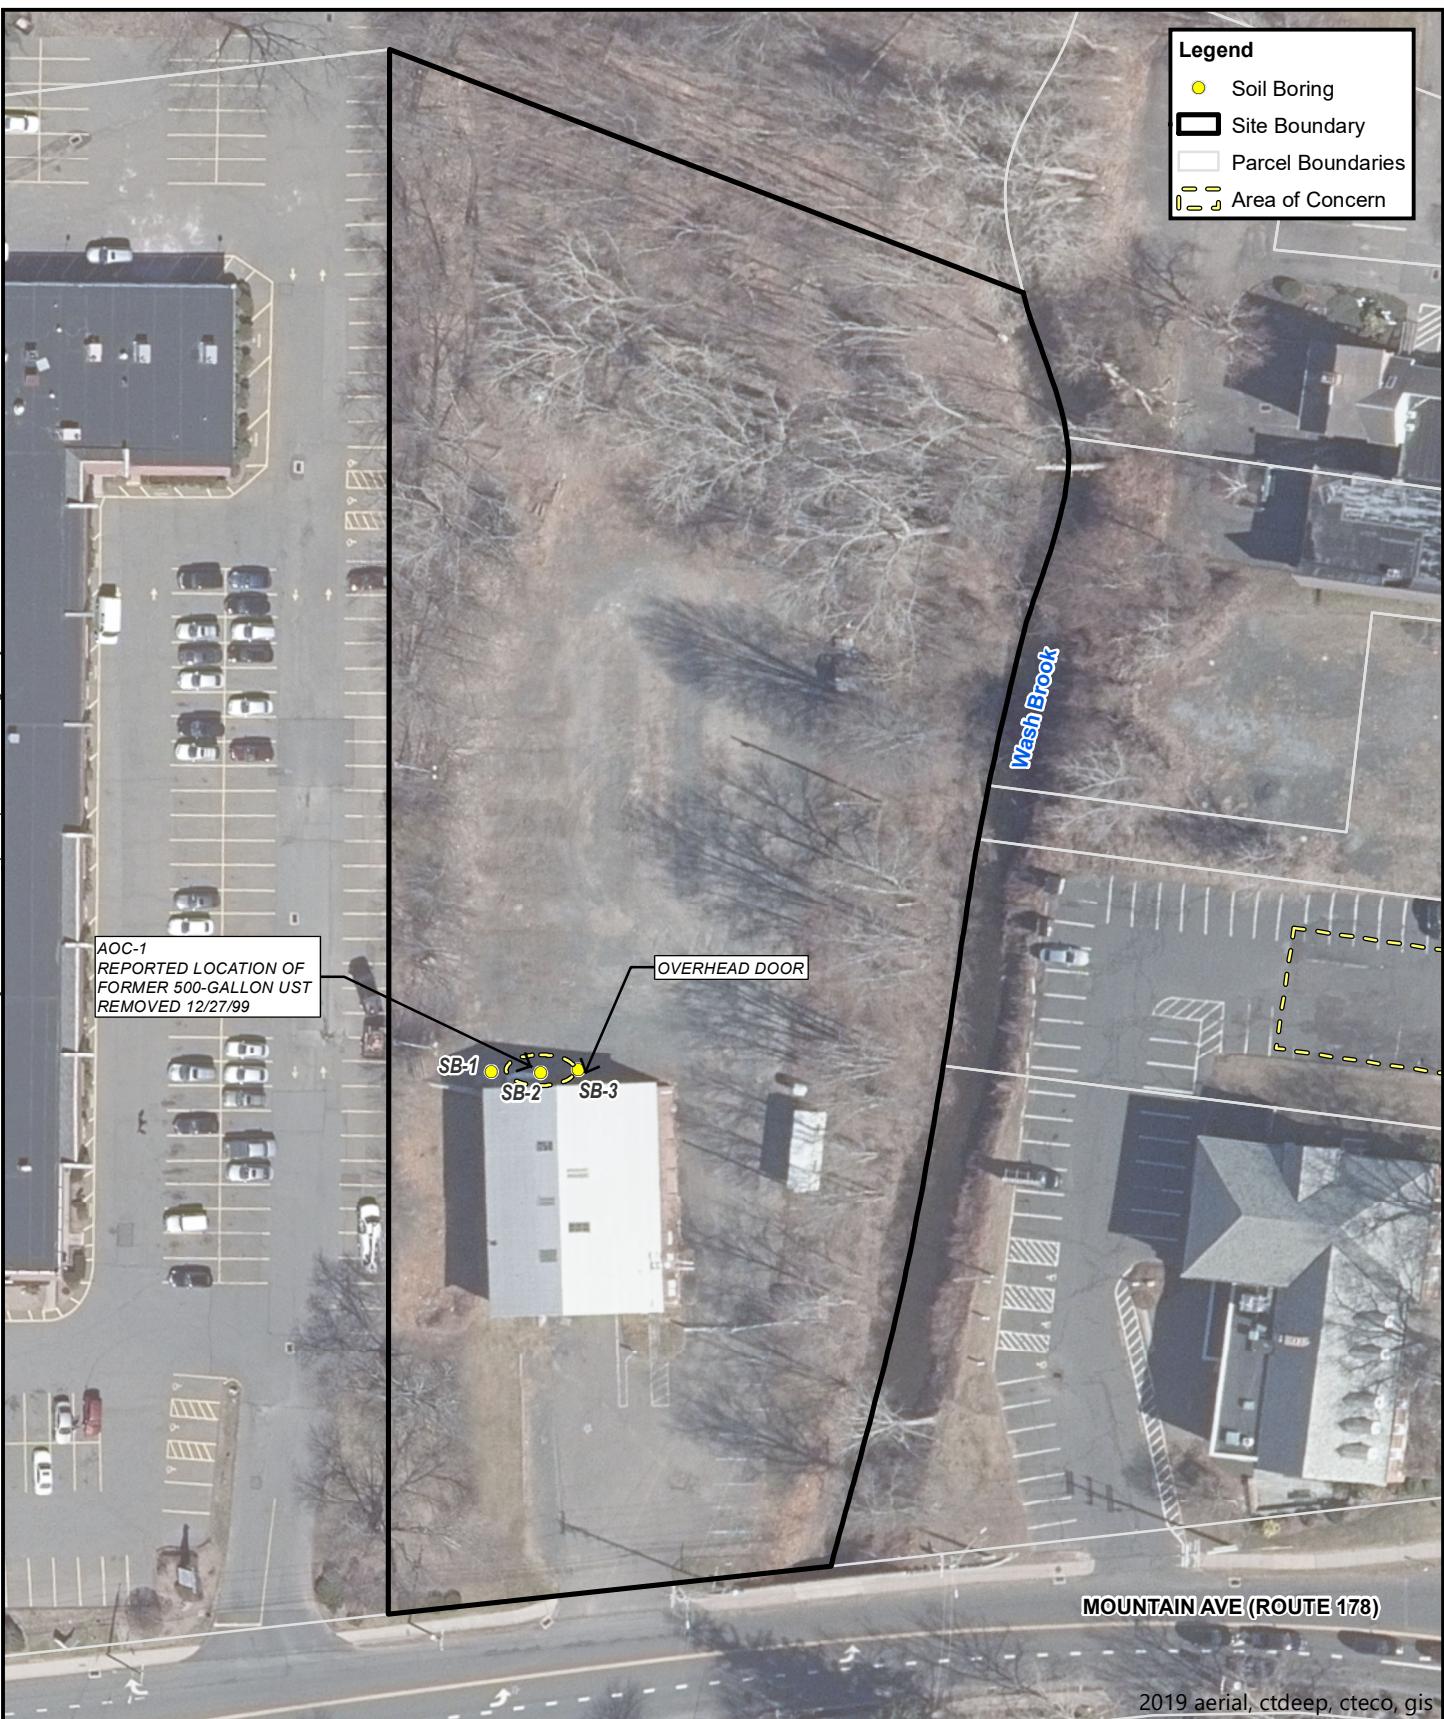
SITE PLAN & SAMPLING LOCATIONS

Based upon the data collected, the soil encountered in the area of the former UST consisted of topsoil over a relatively thin fill layer, then organic silty sand over native outwash deposit of fine sand and silt. Groundwater was encountered at approximately 4 to 5 ft bg. There were no indications of soil impacts in any of the three soil borings based on visual or olfactory observations. The laboratory results further confirm the findings of the Fire Marshal that a release did not occur or impact the surrounding soil. There were no detections of ETPH, SVOCs in any of the three soil samples and only one VOC compound detected at a low concentration was present well below the RSR clean-up criteria. No further investigation is recommended for this AOC.
