PHASE I ENVIRONMENTAL SITE ASSESSMENT

**1015 BLUE HILLS AVENUE
BLOOMFIELD, CONNECTICUT**

**Prepared for:
Town of Bloomfield**

April 2022

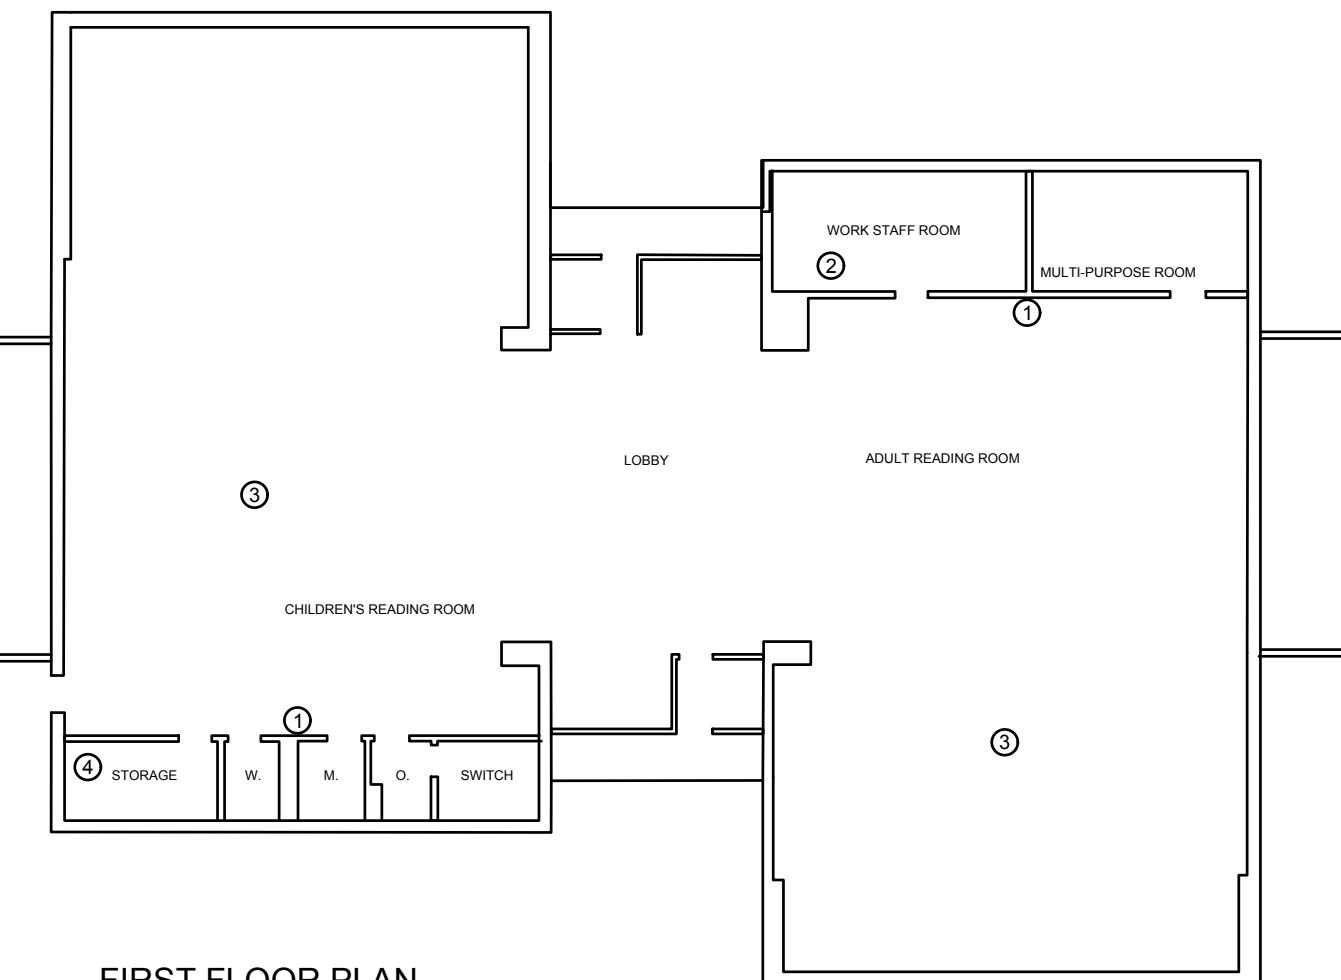
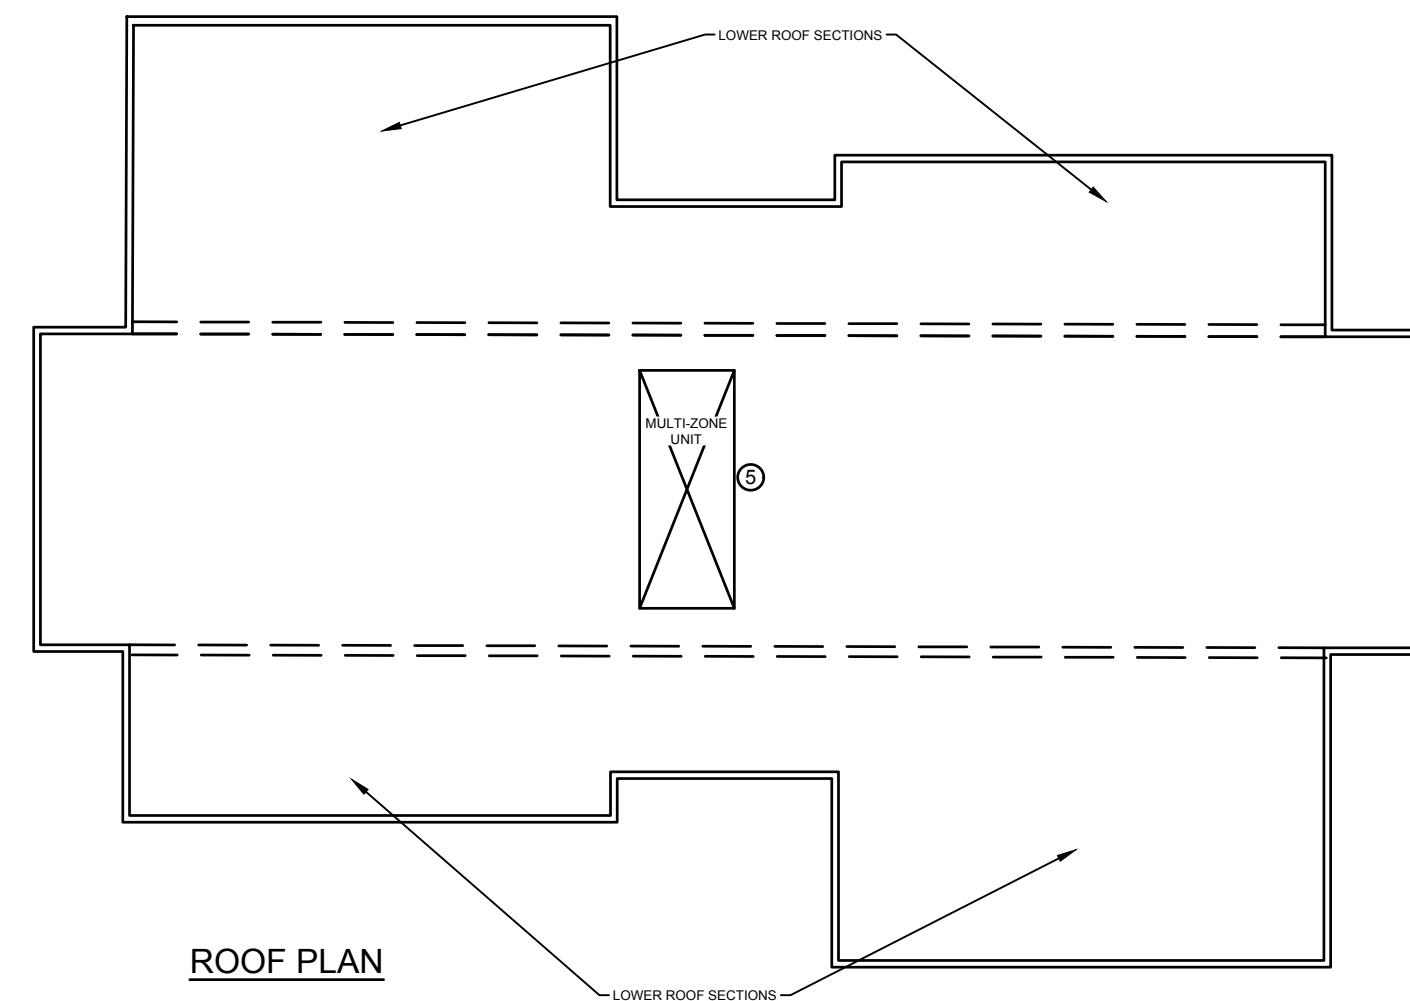
DRAWING

Plan #	Material Description	Location
①	Joint Compound	Interior Walls
②	Black Sink Undercoating	Break Room Sink
③	Carpet Adhesive (with Residual Brown Floor Mastic)	Floor Beneath Carpeting (Green)
④	12"x12" Gray Mottle Floor Tile	Storage Room Floor
⑤	Black Mastic associated with 12"x12" Gray Mottle Floor Tile	
⑤	Vent Mastic (Black)	Main Roof - Center (Lower Near HVAC Unit)

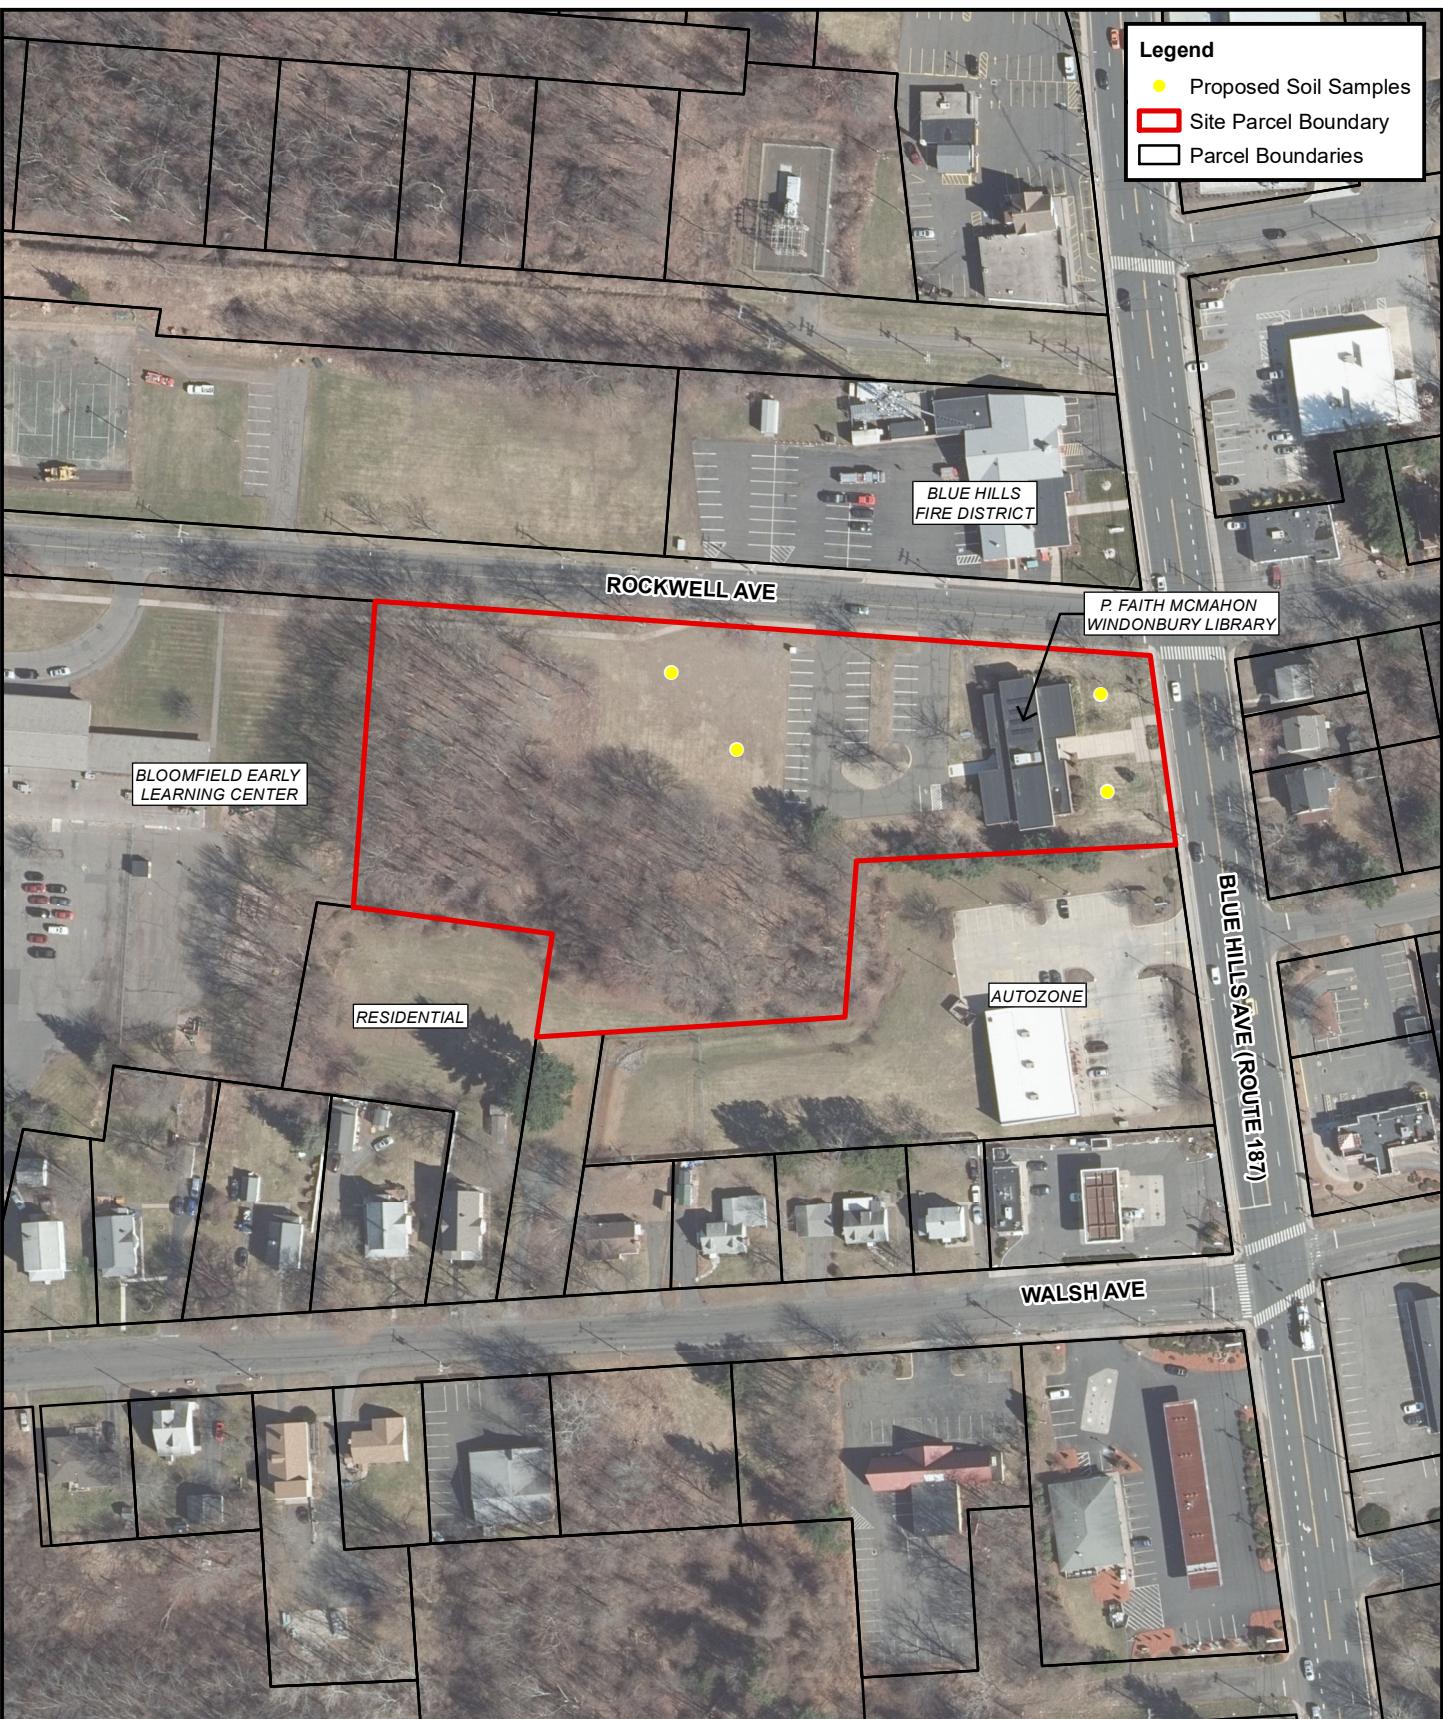
PROPOSED PHASE II SOIL SAMPLES
PHASE I ENVIRONMENTAL SITE ASSESSMENT
TOWN OF BLOOMFIELD, P.FAITH MCMAHON LIBRARY
1015 BLUE HILLS AVENUE
BLOOMFIELD, CONNECTICUT
